SPECIAL PUBLICATION 116

THE NORTHRIDGE, CALIFORNIA, EARTHQUAKE OF 17 JANUARY 1994

DIVISION OF
MINES AND GEOLOGY

**The Northridge, California, Earthquake
of 17 January 1994**

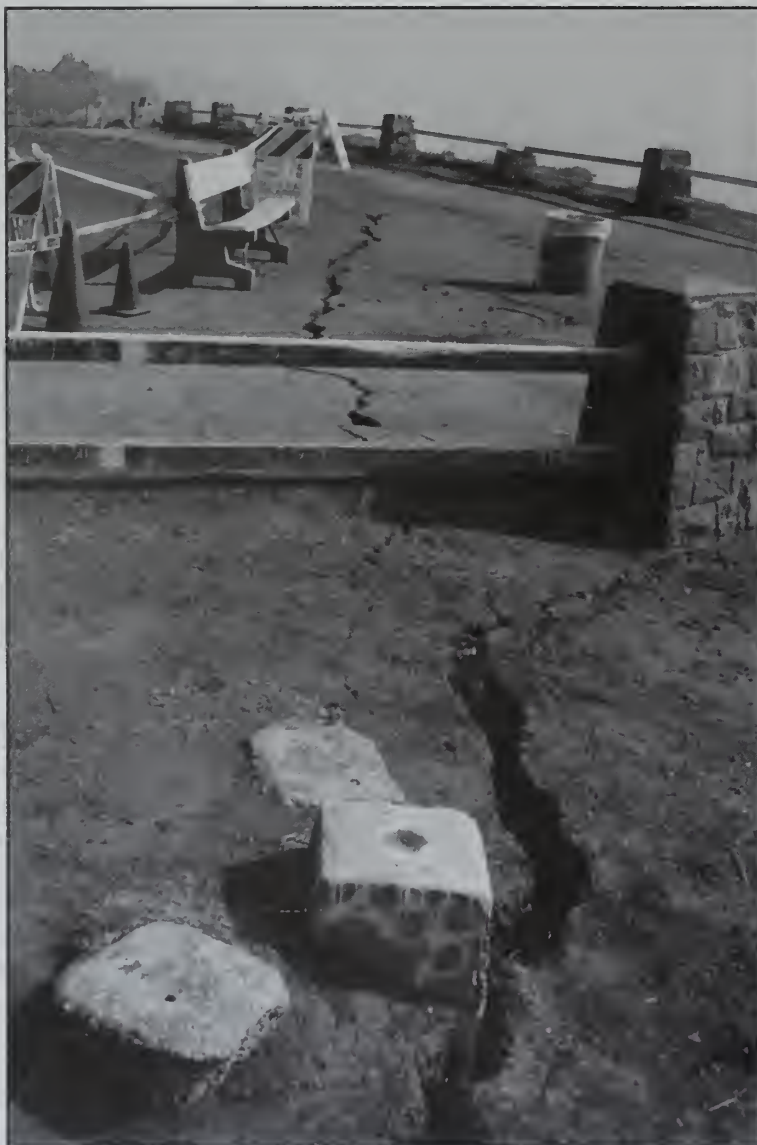
Photo 15. Earthquake-generated extensional cracks along the top of bluffs in old terrace deposits in the Palisades Park, Pacific Palisades, just east of Temescal Canyon. Photo by S.S. Tan, 1/20/94.

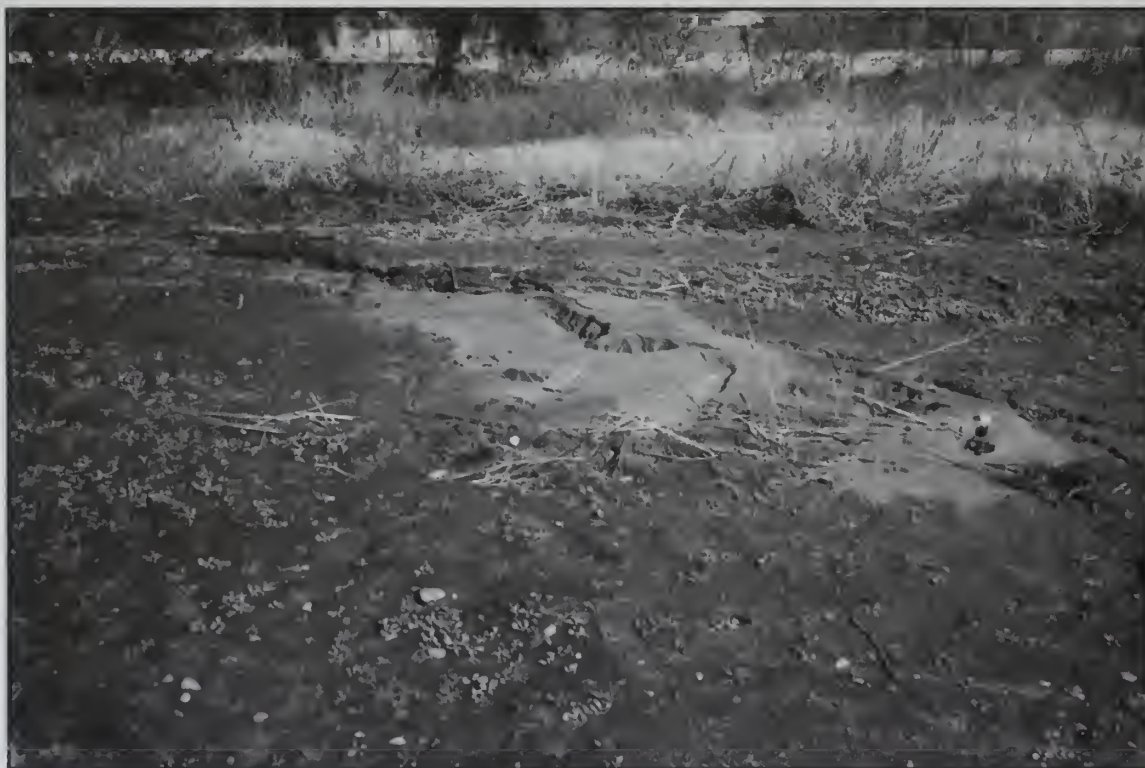
Photo 17. Irregular fissure along which fine sand (light tone) was ejected as well as water that soaked the surrounding ground (dark tone) in an open field just south of the intersection of White Oak Creek channel and Arroyo Simi channel, directly east of Simi Country Mobile Estates Park, Simi Valley. Features are primary evidence of liquefaction. View to southeast. Photo by P. J. Irvine, 1/25/94.

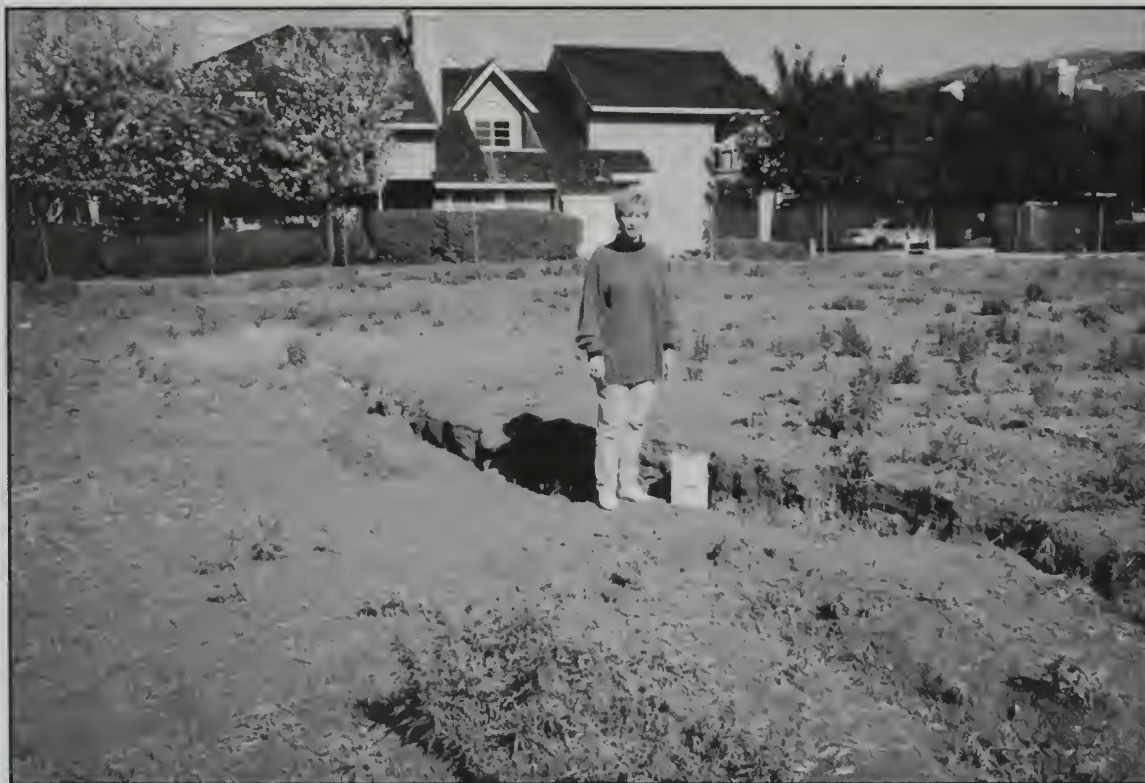
Photo 18. Prominent north-trending fissure, which crosses graded fill pad east of Rory Lane in Simi Valley, exhibited as much as 12 inches (30 cm) of vertical displacement, down on the west (toward Arroyo Simi). This feature appears to be related to differential settlement, combined with possible lateral spreading, of fill above old channel deposits. Photo by P.J. Irvine, 1/25/94.

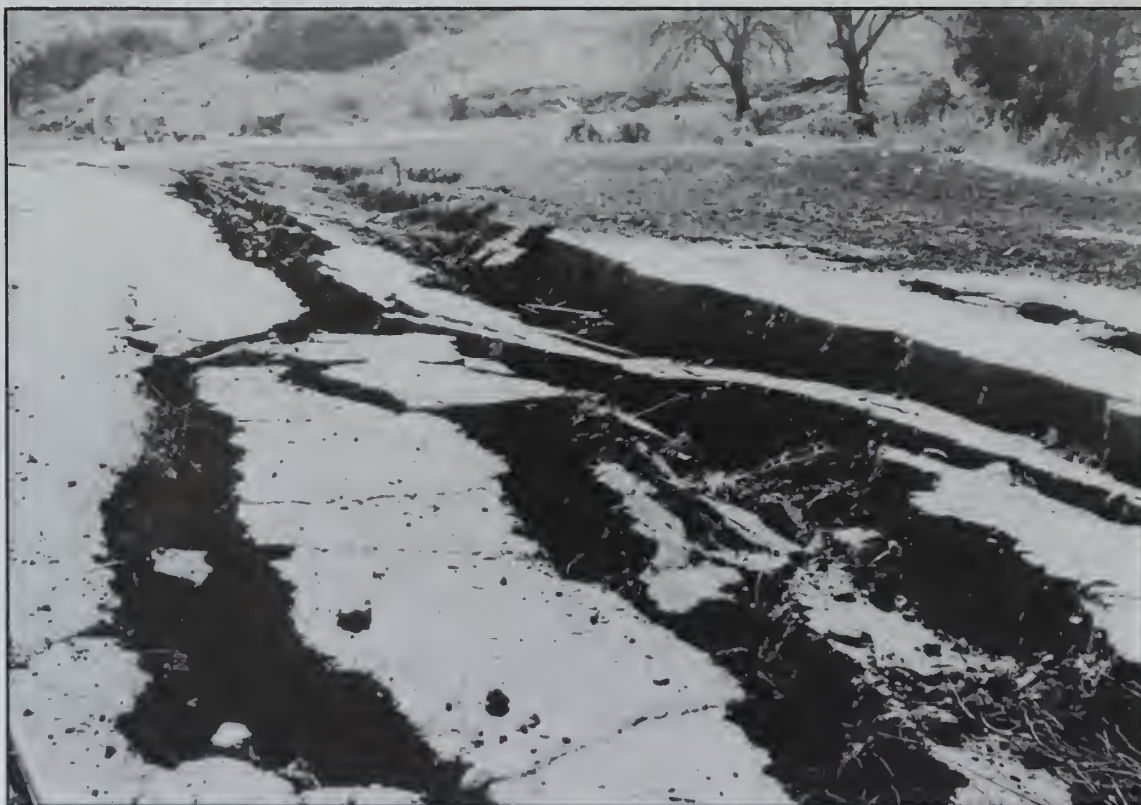
Photo 19. View eastward toward prominent, deep cracks and fissures due to lateral spreading and slumping of fractured, brittle fill materials along south side of Arroyo Simi, south of the Metrolink Station in Simi Valley. Photo by J. Fields, City of Simi Valley, taken 2/11/94.

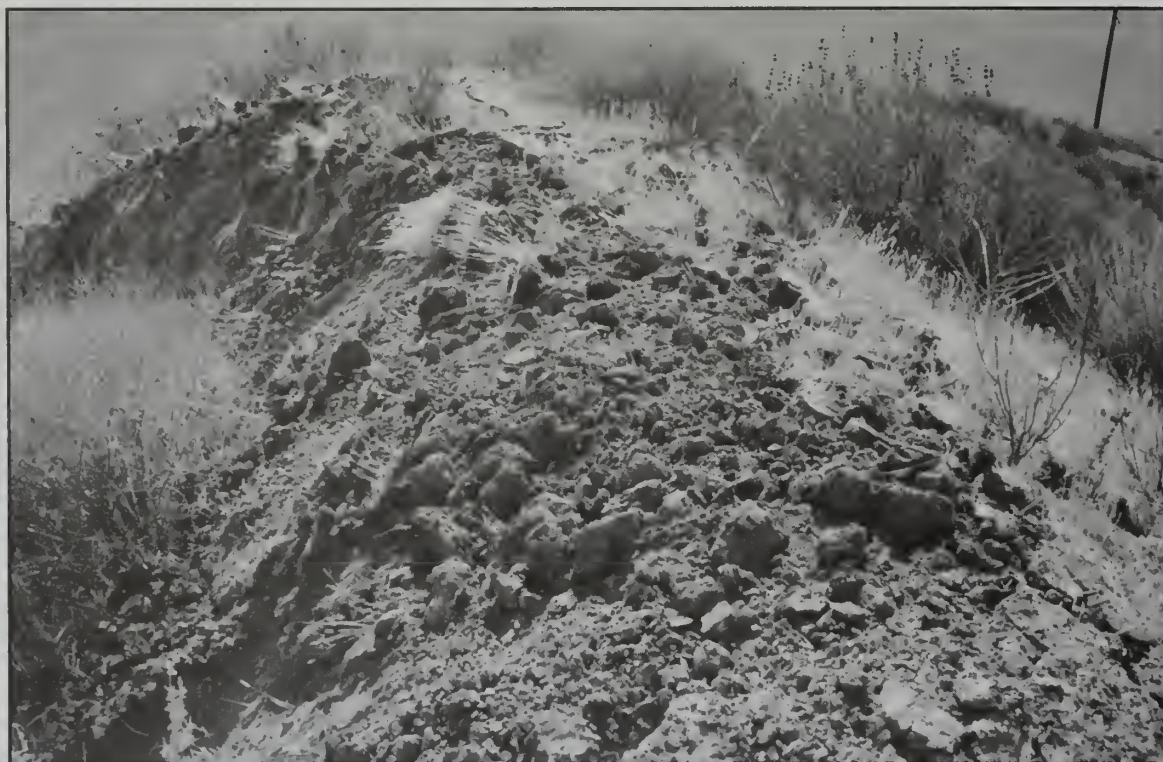
Photo 20. Southwest-trending shattered ridgetop in Saugus Formation sandstone 0.5 mile (0.8 km) east of the junction of Interstate 5 and State Highway 126 (Castaic Junction). Photo by S.S. Tan, 1/22/94.

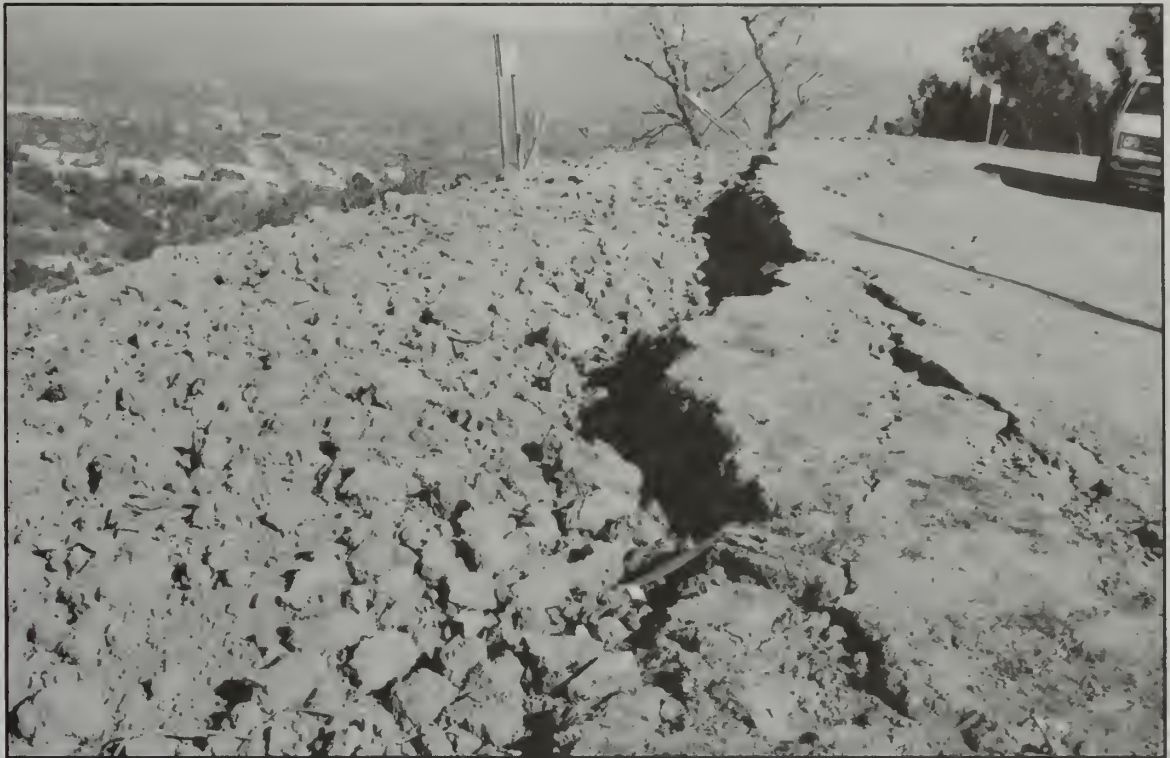
Photo 21. Shattered fill material along north side of Mulholland Drive, east of Benedict Canyon, Sherman Oaks, Santa Monica Mountains. Photo by S.S. Tan, 1/18/94.

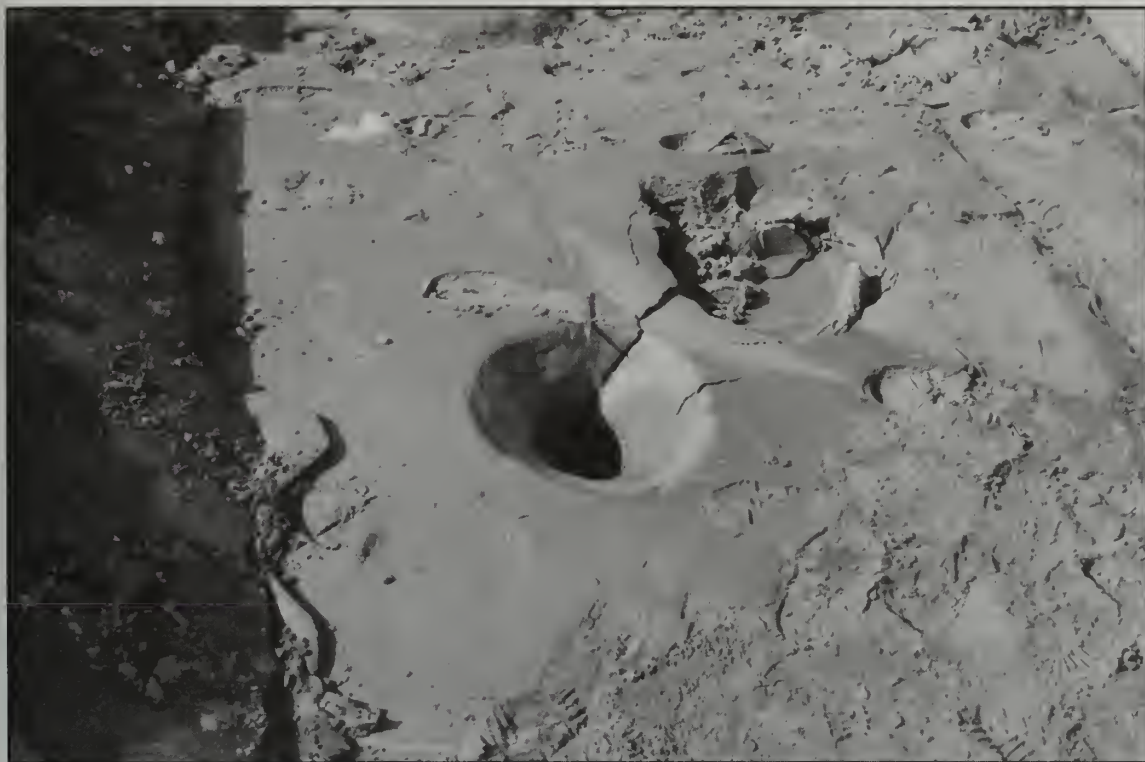
Photo 24. Sand boil or sand "volcano" resulting from liquefaction of fine-grained fill material derived from sand dunes that was emplaced over former beach and lagoonal deposits to create Mole B, King Harbor Marina, Redondo Beach. Note uniformity of material and slick, moist surface from ejected water on slopes of boil. Photo by S.S. Tan, 1/20/94.

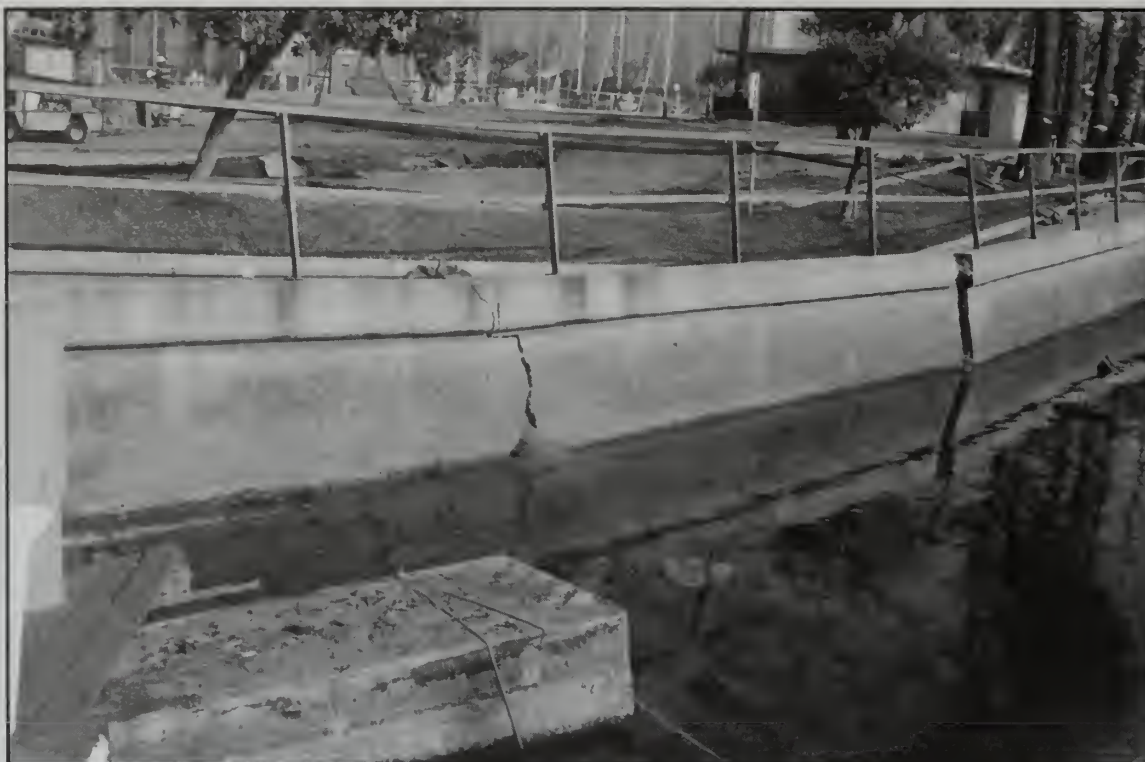
Photo 26. Failed south-facing retaining wall along Mole B, King Harbor Marina, Redondo Beach. Note cone of fine sand at base of crack, left of center. Wall was deflected about 17 feet (5 m) from original position as a result of lateral spreading. Photo by S.S. Tan, 1/20/94.

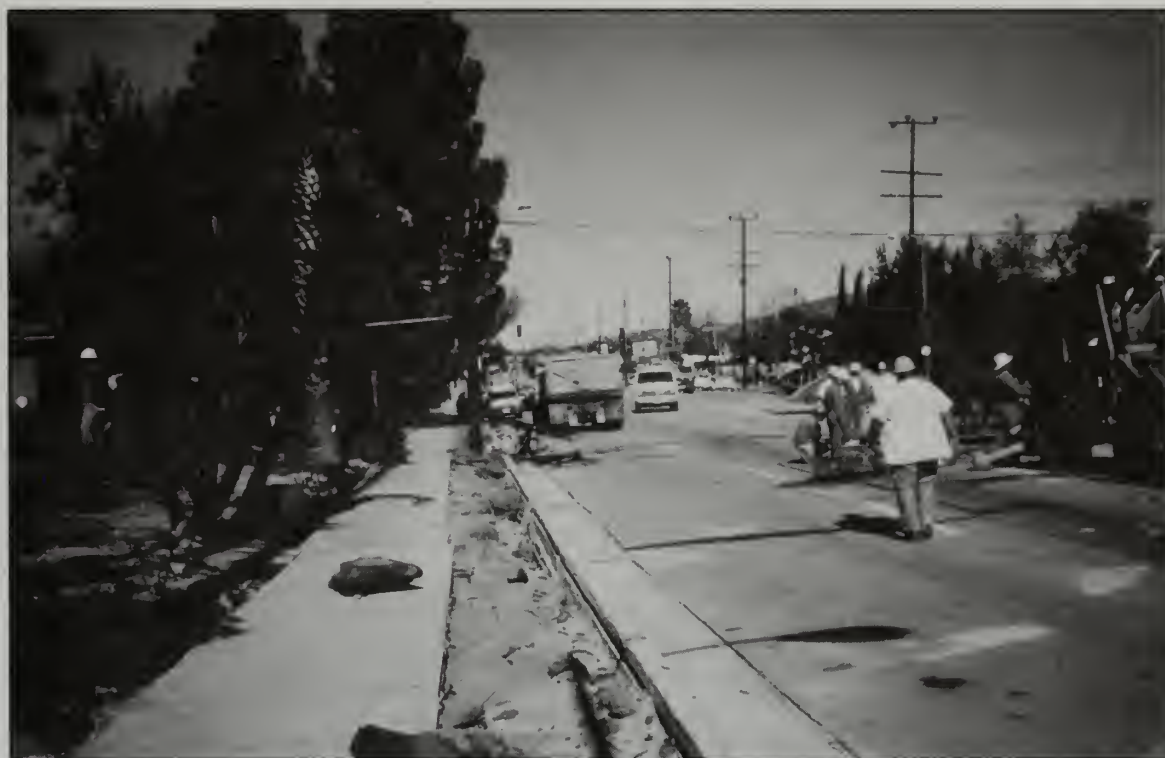
Photo 1. Looking north along Balboa Boulevard which was offset by a zone of extensional and left-lateral fractures that also ruptured natural gas and water transmission lines. Fractures were determined to be caused by lateral spreading (Locality 3a, Figure 2).

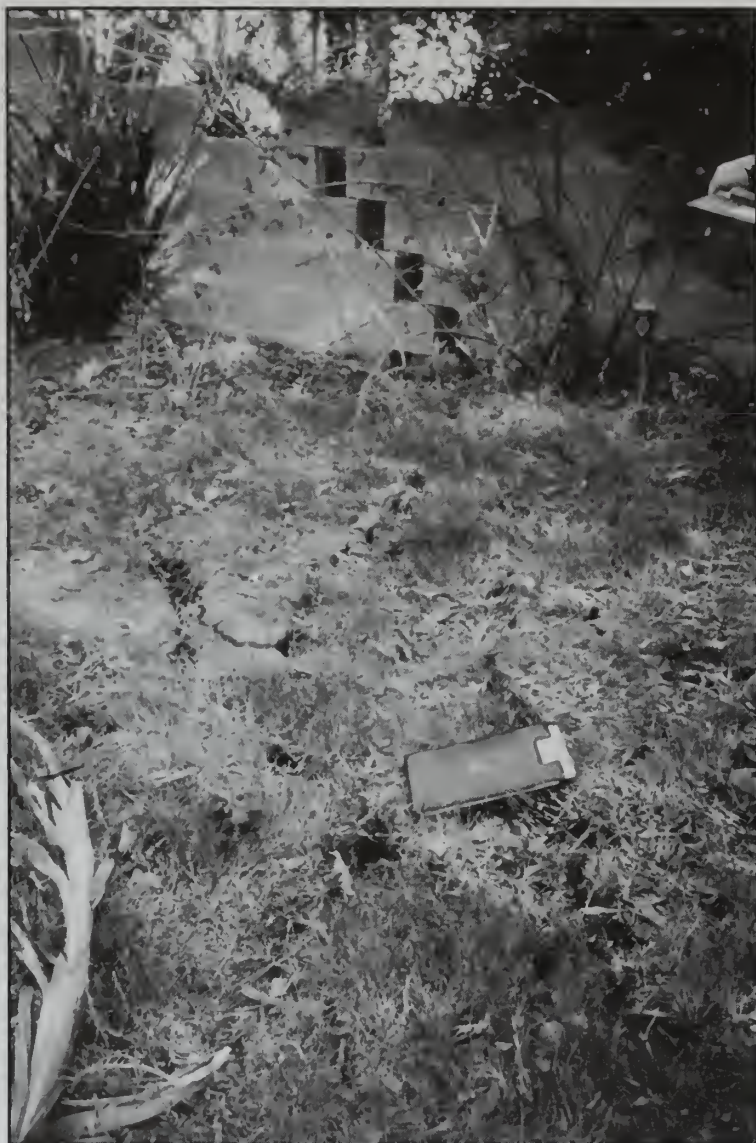
Photo 2. Northeast-trending extensional ground cracks in lateral spread feature (Locality 3a, Figure 2) east of Balboa Boulevard. Concrete block wall is pulled apart about 15 cm. Nearby houses and swimming pool also were damaged by ground ruptures.

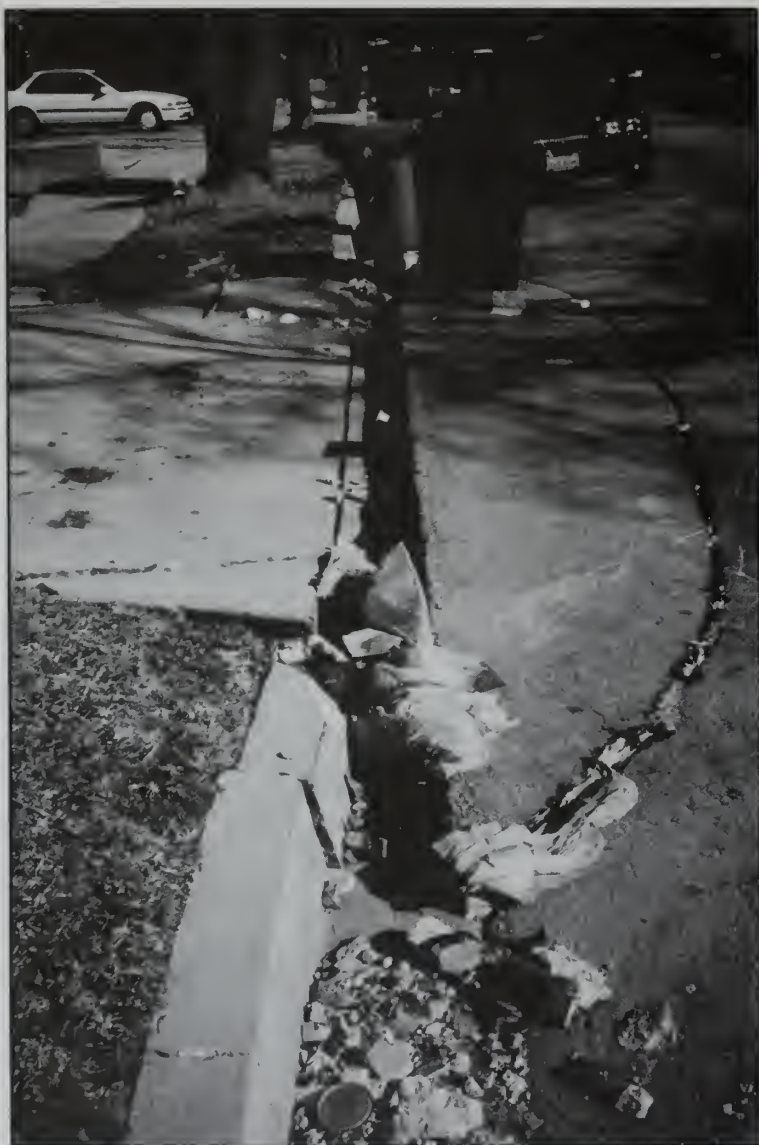
Photo 4. Looking east on Landers Street where driveway pushed gutter southward under street paving about 25 cm due to compression at toe of lateral spread feature (Locality 3a, Figure 2). Also note buckled sidewalk at upper left.

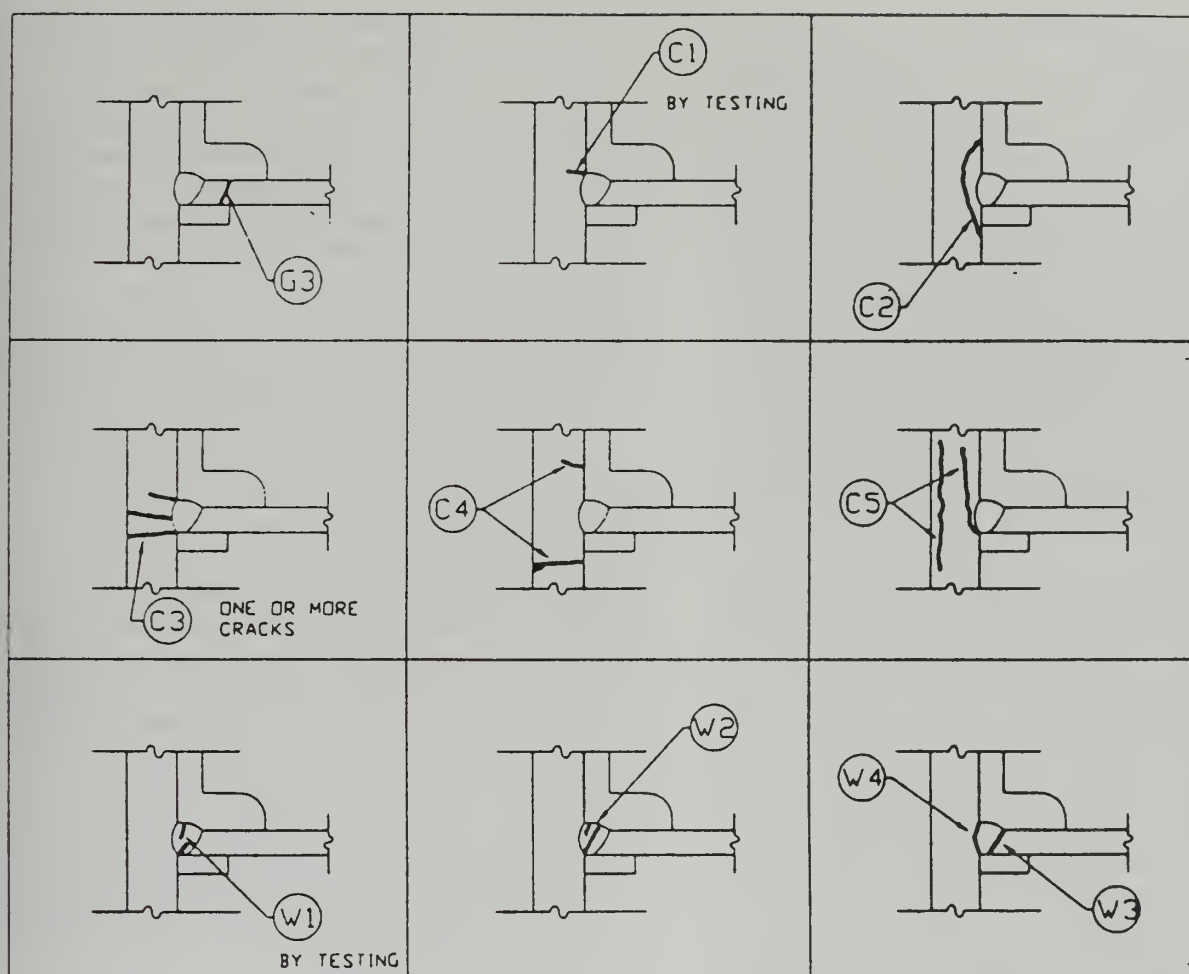
Figure 2. Types of damage found in beam-to-column connections in steel Special Moment Resisting Frame buildings. Type G3 illustrates brittle cracking, failure, or tearing of the beam web. Types W3 and W4 illustrate failure adjacent to the complete joint penetration beam flange-to-column flange weld, and types W1 and W2 illustrate failure within the complete joint penetration beam flange-to-column flange weld. Column damage is illustrated by Type C1–5.

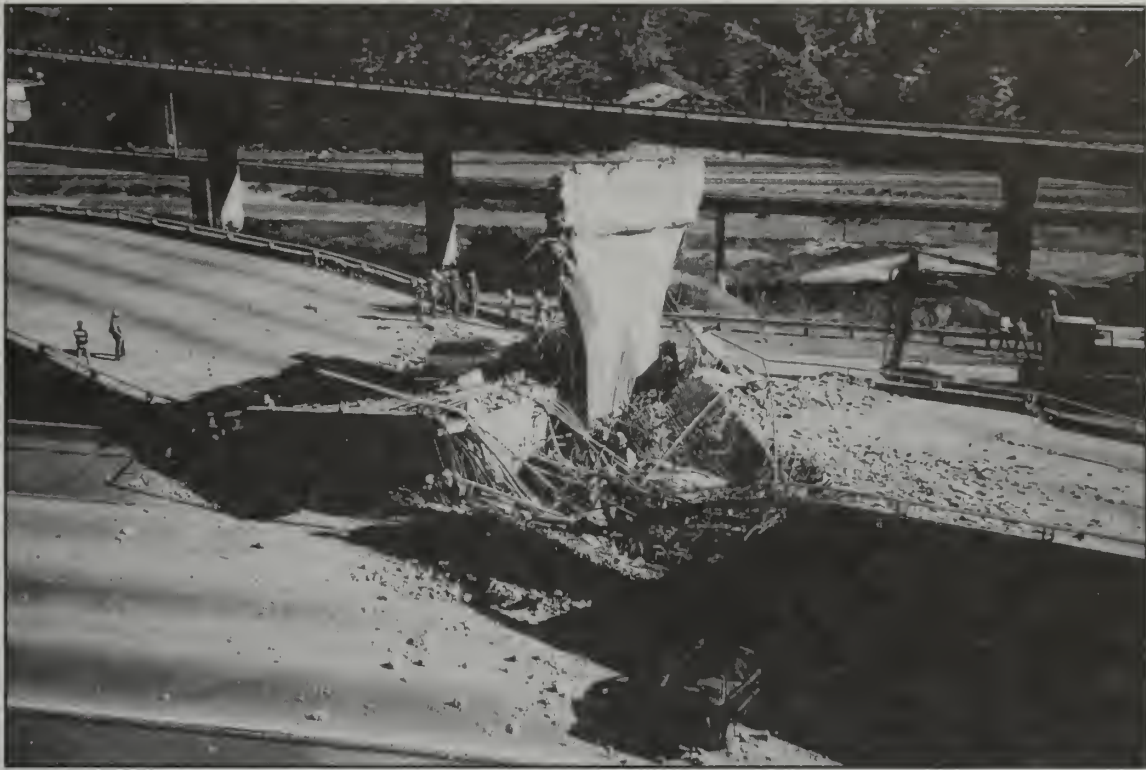
Photo 3. Damage at Pier #3, Route 14/5 Separation and Overhead.

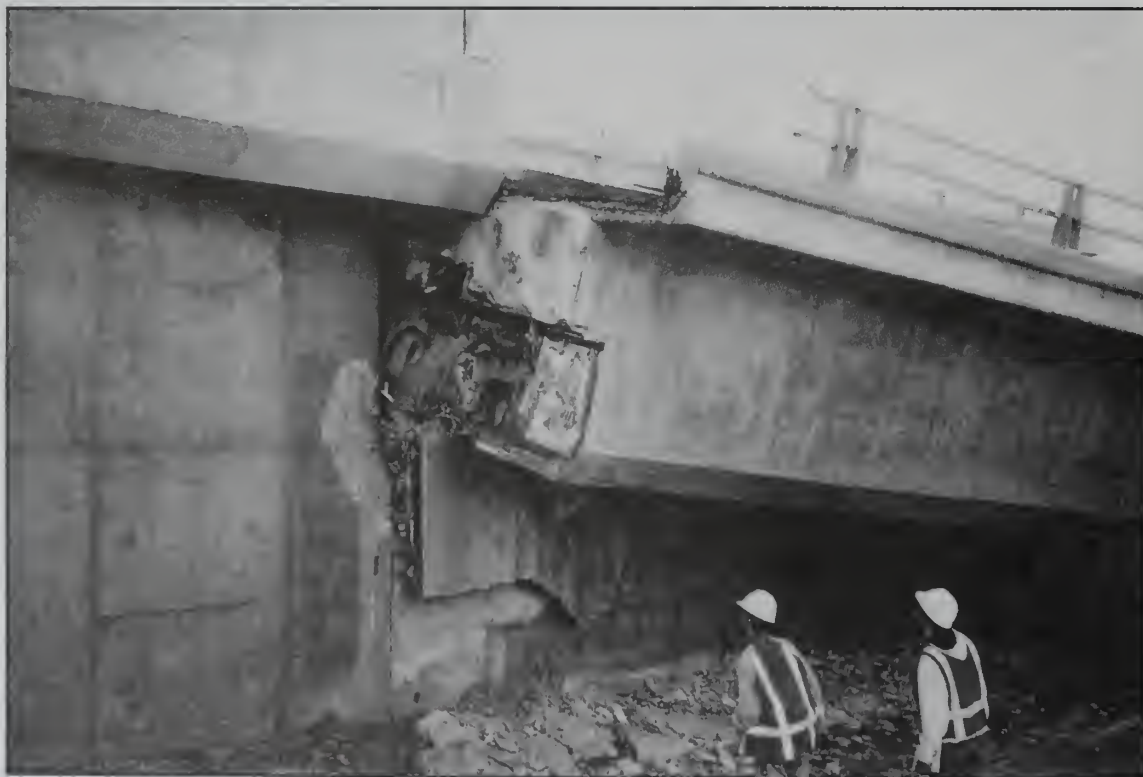
Photo 4. Earthquake damage at Abutment #1 to the North Connector Overcrossing.

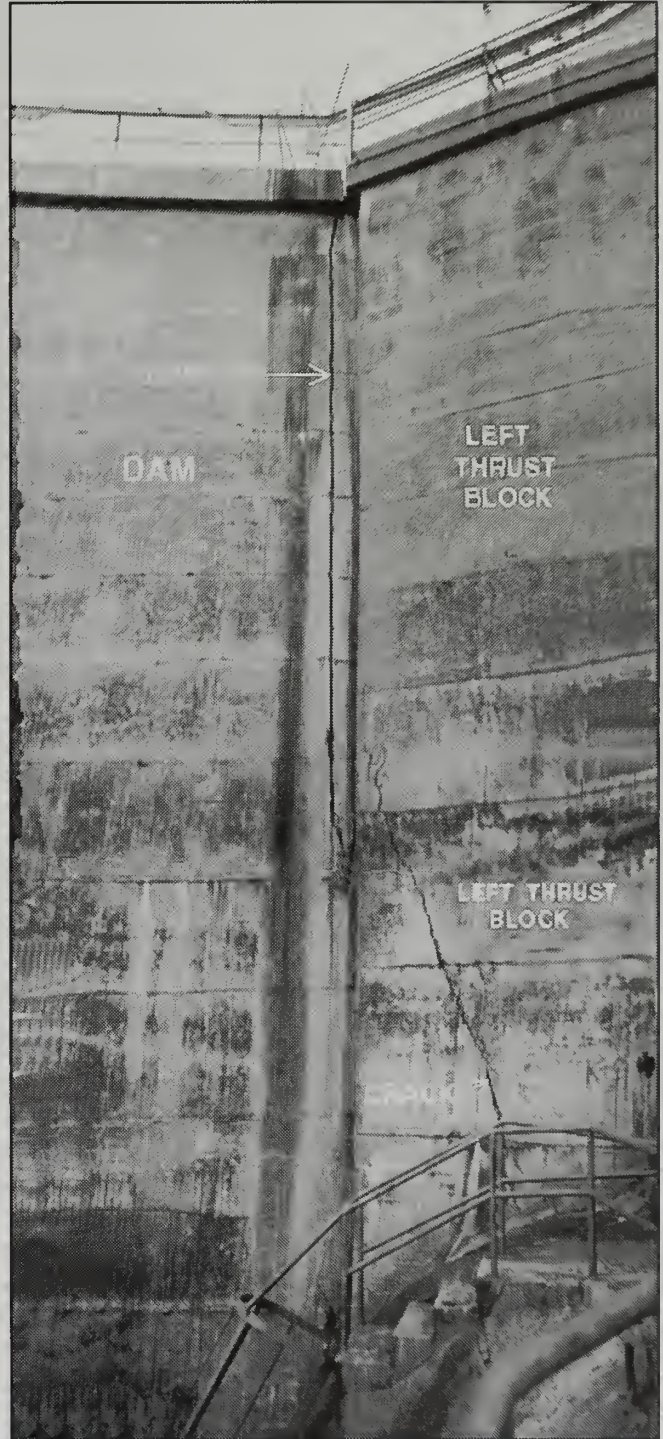
Photo 5. A joint between the left abutment concrete thrust block and the end of the dam opened approximately 2 inches at Pacoima Dam.
